# Tesco Dilapidation Guidance Update - SSR

Update on the guidance on  
completing a Independent  
Dilapidation Report for a  
Tesco in store bakery

# Oven SSR Checks

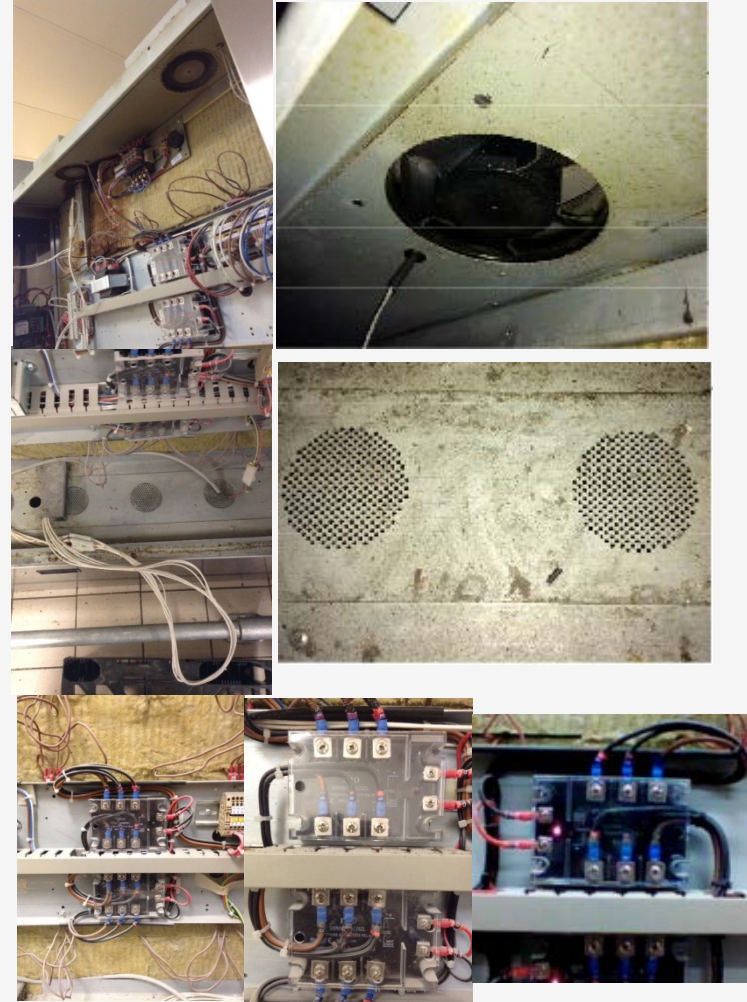
## Solid State Relay Checks

- Cooling Fans
  - Close pictures of the fans, ideally stopped
  - We need to be able to see the blades etc. to show if there is any contamination
- Ventilation Holes
  - Close up pictures of the holes so we can see if they are clear or not
- Solid State Relays
  - At least three pictures
  - One picture for each pair of SSR's
  - Close so we can see the facia
- If there is any issues then please take more pictures.
- Please remember, if you cannot access the side we need a picture showing why.

- Check no debris has been left on base
  - Solid State Relays – 2 x located on each deck chassis
    - Check wiring for signs of overheating
    - Remove cover and check for blistering or hair line cracks on face of SSR

- Check insulated terminals for signs of overheating (browning)
    - Check SSR is securely fastened to back plate
    - Check all screw connections for tightness
